What Happened?

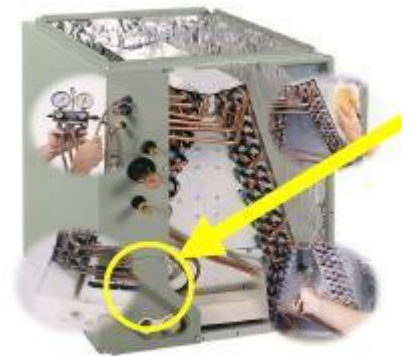
- Vibration caused failure
- Age and fatigued metals caused failure

Most newer air conditioning and heat pump systems have a TXV instead of a fixed orifice which meters the refrigerant flowing through the tubing. In addition to improper metering, the devices can also cause leaking.

- Replace Thermal Expansion Valve
- Possible System Replacement
